**COMBINATION LEAD BASED PAINT
INSPECTION AND
RISK ASSESSMENT SURVEY**

Vacant
1396 Proper Avenue
Burton, MI-48529
Owner's Phone #: (810) 766-6568
Date of Construction: 1954

DATE(S) OF ASSESSMENT:
6-3-10

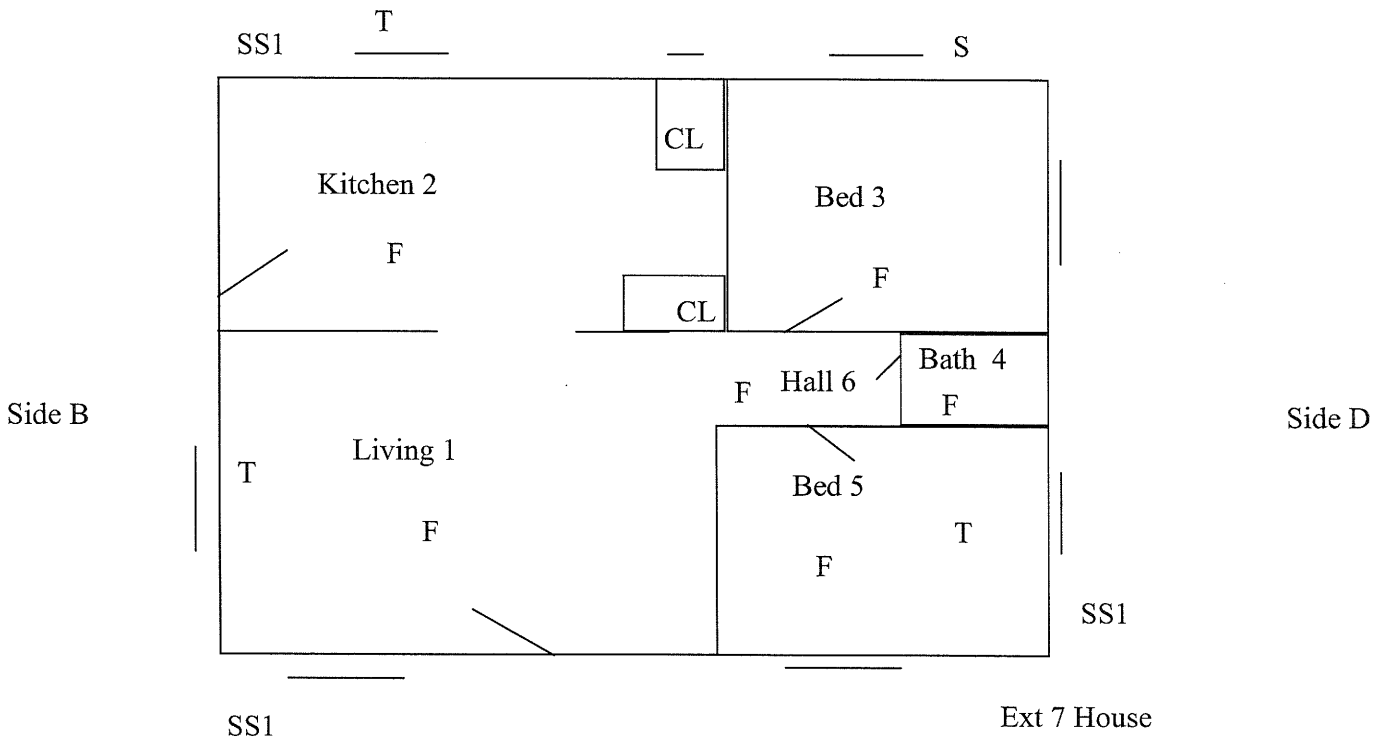
Vacant
1396 Proper Avenue
Burton, MI-48529

F = Floor Dust Wipe Sample
 S = Windowsill Dust Wipe Sample
 T = Window Trough Dust Wipe Sample

Please Note: This is a rough floor plan only. All items, (doorways, Windows, etc.) may not be included in this illustration. Also, room and component sizes are not drawn to scale.
